January 1993

Appendix I
Exposure of Personnel to DU
Contamination During the Persian Gulf War

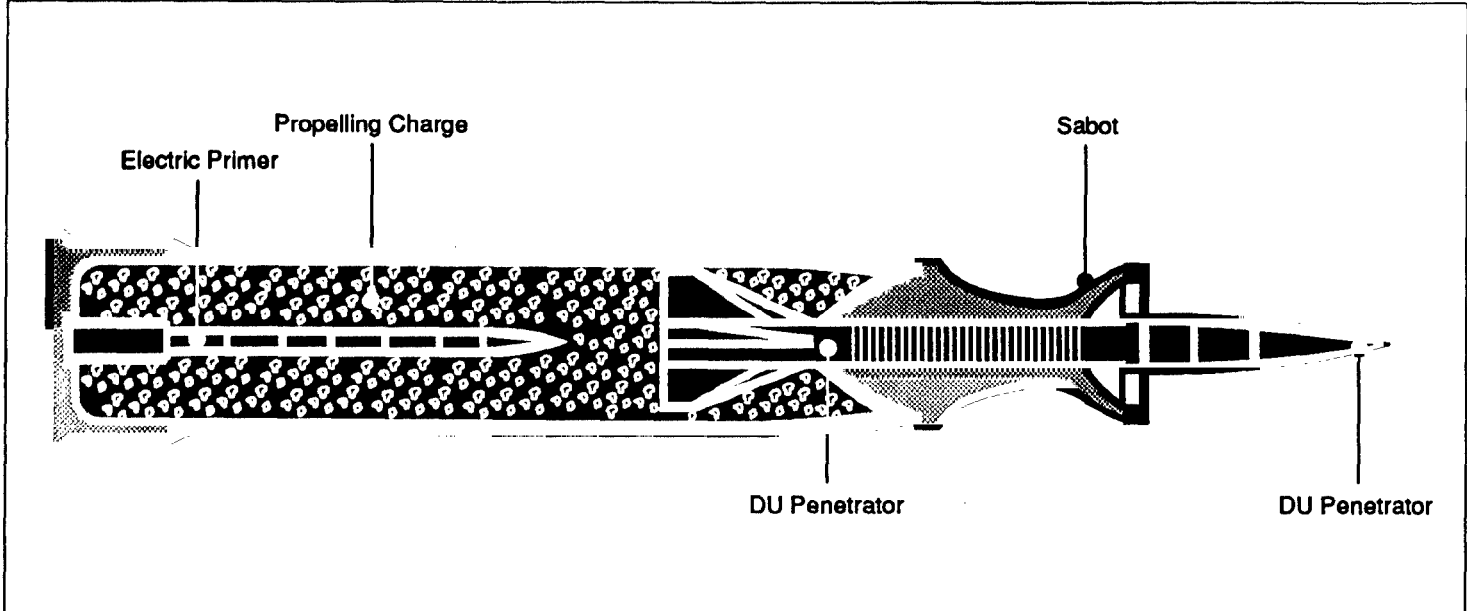
Figure I.1: 120-mm Armor-Piercing Round With DU Penetrator

Because DU is extremely dense, it can be used to protect against penetration by less dense metals or to pierce other metals such as armored targets. U.S. tanks and the Air Force's A-10 close air support aircraft fire DU munitions, and some M1A1 Abrams tanks have DU in portions of their armor. According to the Army, during the Persian Gulf War, 29 U.S. Army combat vehicles—15 Bradley Fighting Vehicles and 14 Abrams tanks—were contaminated after being hit by DU rounds from Abrams tanks or after experiencing the ignition of stored DU ammunition caused by accidental on-board tank fires or being struck by a Hellfire missile fired by a U.S. helicopter.
